Burst Testing of Filament-Wound Graphite-Epoxy Composite Cylindrical Tubes

1 November 2002

D. J. CHANG, H. A. KATZMAN, J. P. NOKES, P. M. ADAMS,
S. T. AMIMOTO, P. R. VALENZUELA,
T. V. ALBRIGHT, and P. L. JOSEPH
Space Materials Laboratory
Laboratory Operations

SPACE AND MISSILE SYSTEMS CENTER
AIR FORCE SPACE COMMAND
2430 E. El Segundo Boulevard
Los Angeles Air Force Base, CA 90245

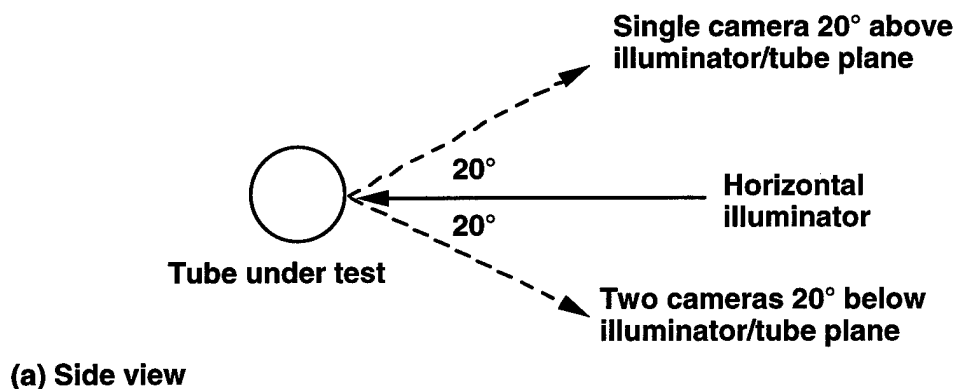
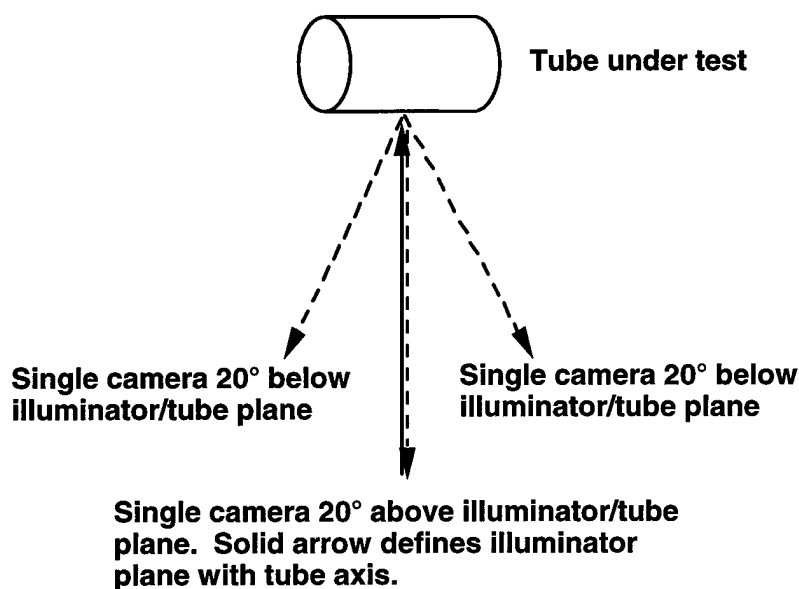
Figure 7.8. Two projections of the geometry of 3-D speckle tube and camera imaging locations. (a) Side view and (b) Top view.

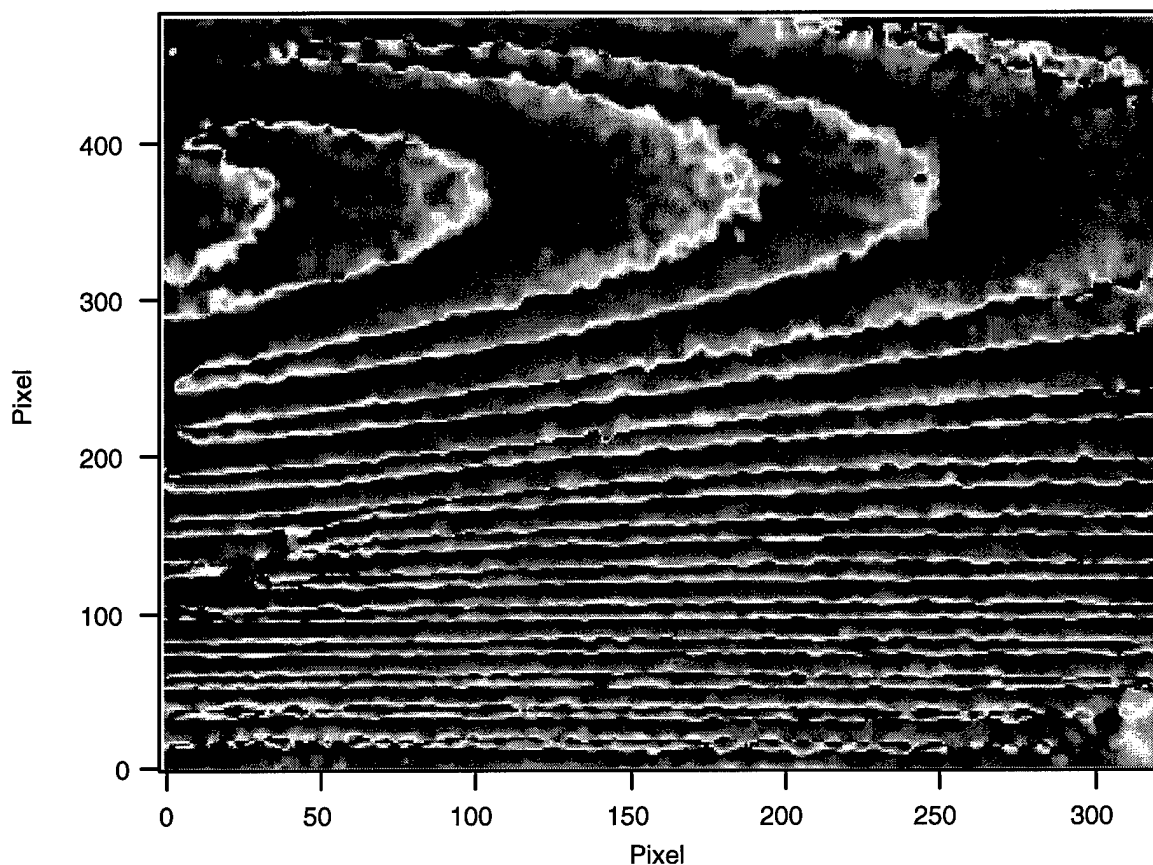
Figure 7.9. The phase of an empty graphite epoxy tube deformed by placing a wrench into the center of the tube. The image is switched around, upside-down and left to right. The motion of the tube is complex. Fringes in the lower right corner are not well defined due to poor signal levels. The phase is shown as varying from 0 to 2π as the intensity is modulated from 0 to 256 gray scale. The field of view is about 5.0×6.0 cm on the tube.
